# Lab Report

## Overview of Dust Bag(s)/Project Information

**4) Problem (per customer):** Poor overall bag performance

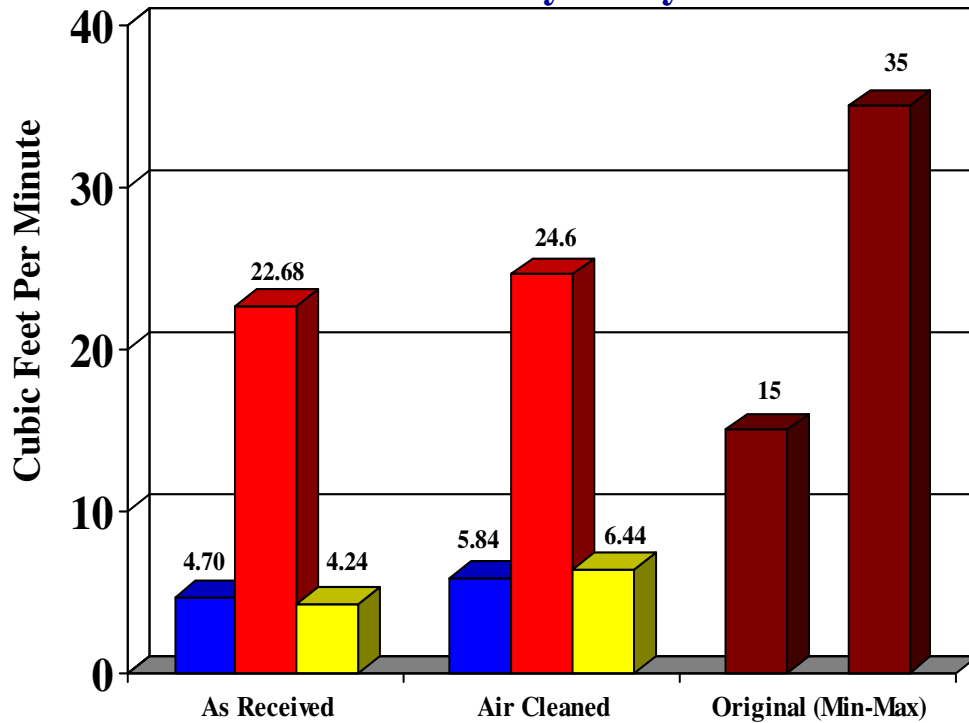
FIGURE # 1

**Additional Comments:** The permeability and Mullen Burst strength after air pulse cleaning were 12.29 cfm and 330 psi respectively. This represents an 18% loss in permeability (original specification of 15 cfm) and a 45% loss in Mullen Burst strength (original specification of 600 psi).

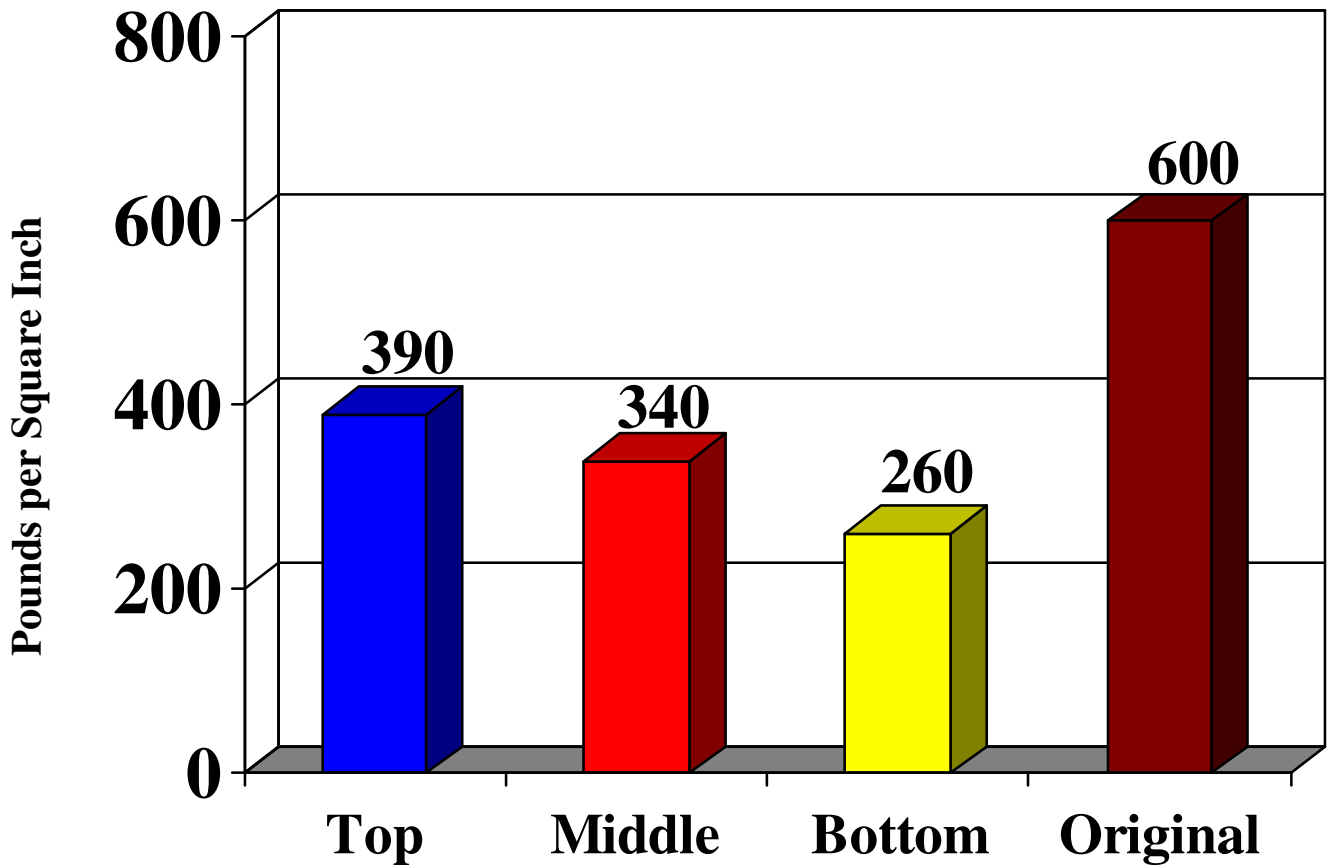
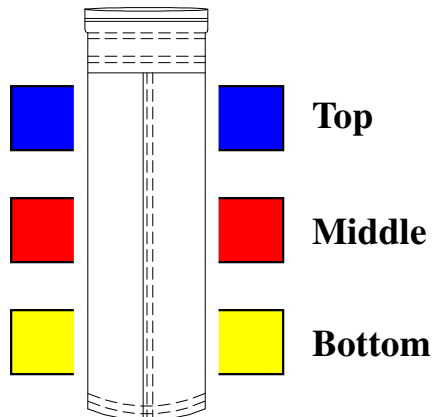
FIGURE # 2

**Chemical Attack:** Possible due to a 45% loss in Mullen Burst strength.

**Hydrolytic Attack:** Possible due to a 45% loss in Mullen Burst strength.

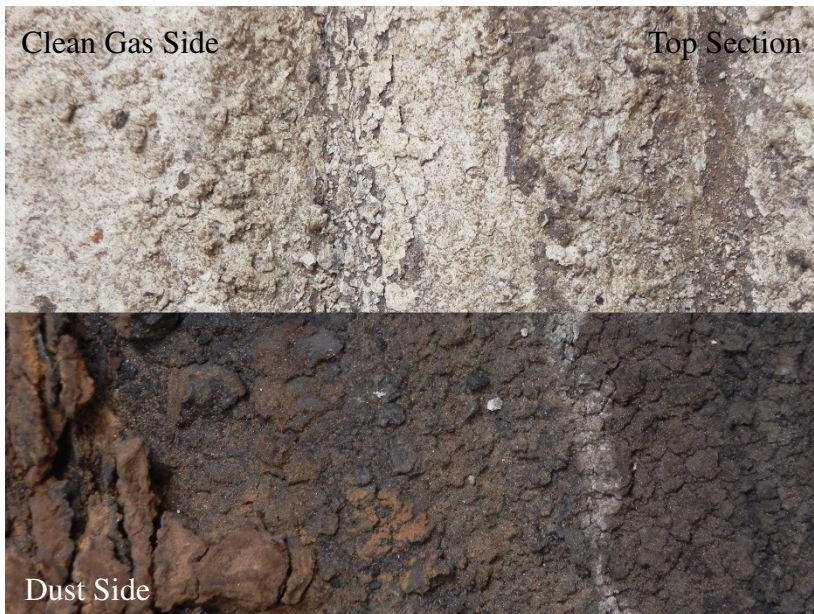
**Text:** Photograph # 1  
Clean Gas Side vs. Dust Side view of the top section. Up to a 1" thick layer of hardened aggressively attached dust was present on the Dust Side (exterior) surface. A 1/8" thick layer of hardened aggressively attached dust was present on the Clean Gas Side (interior) surface. This photograph is also representative of the middle section of the filter bag.

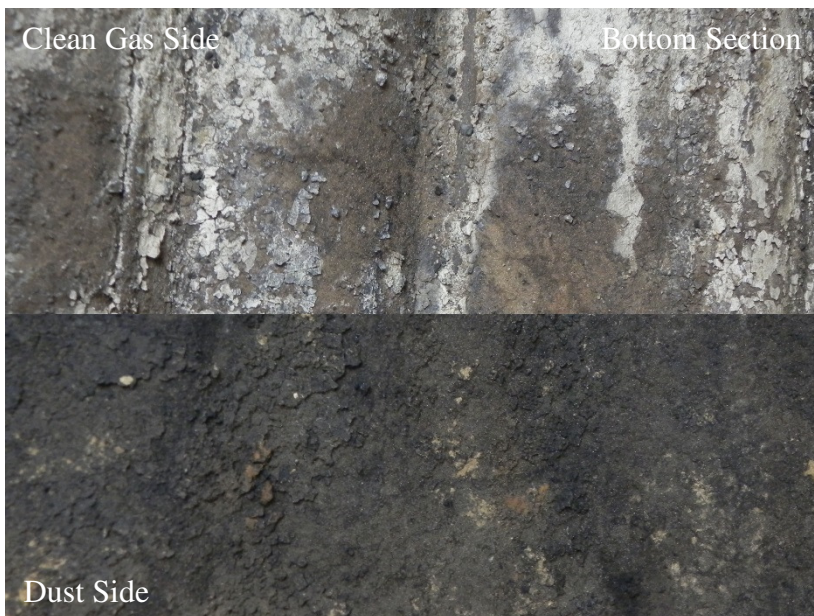
**Text:** Photograph # 2  
Clean Gas Side vs. Dust Side view of the bottom section. Up to an 1/8" thick layer of hardened aggressively attached dust was present on the Dust Side (exterior) surface. A 1/16" thick layer of hardened aggressively attached dust was present on the Clean Gas Side (interior) surface.

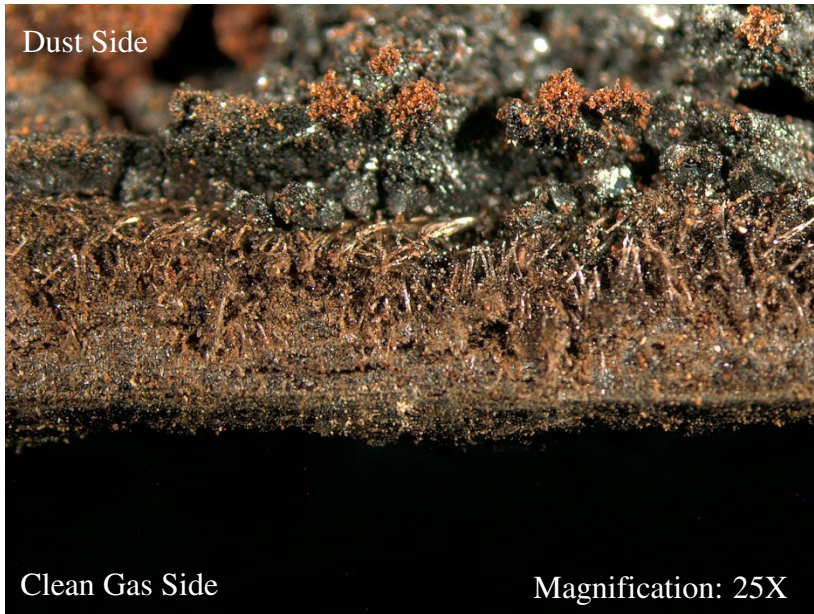
**Text:** Photograph # 3  
Cross section view from the top of  
the bag.  
\_\_\_\_\_  
\_\_\_\_\_  
\_\_\_\_\_  
\_\_\_\_\_  
\_\_\_\_\_  
\_\_\_\_\_  
\_\_\_\_\_  
\_\_\_\_\_

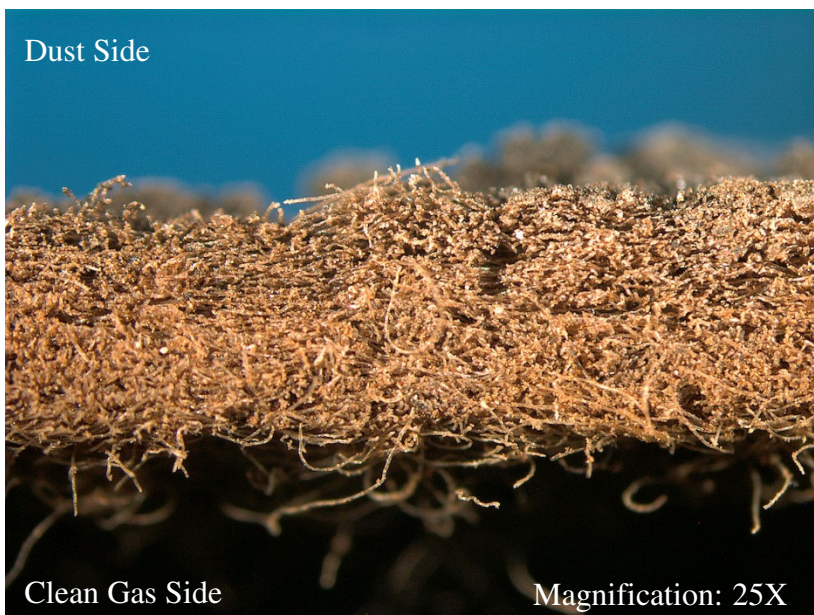
**Text:** Photograph # 4  
Cross section view from the middle  
of the bag.  
\_\_\_\_\_  
\_\_\_\_\_  
\_\_\_\_\_  
\_\_\_\_\_  
\_\_\_\_\_  
\_\_\_\_\_  
\_\_\_\_\_  
\_\_\_\_\_

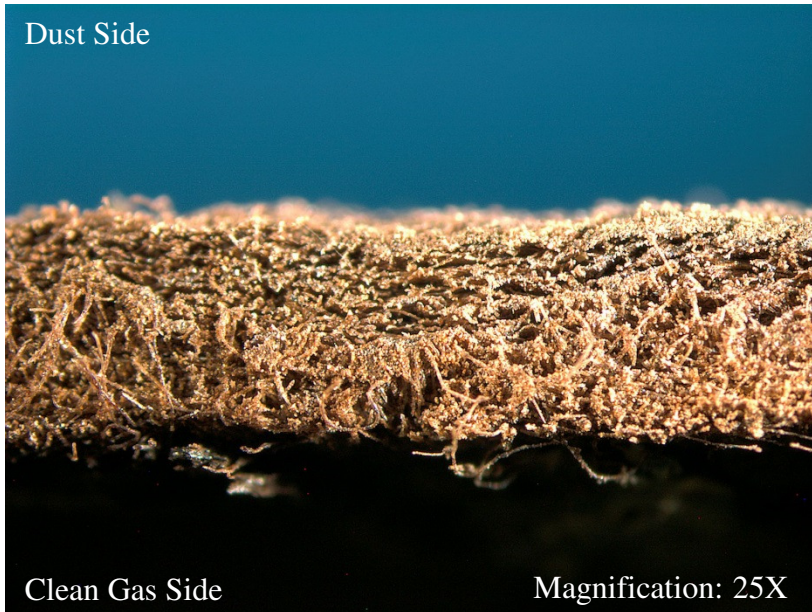
**Text:** Photograph # 5  
Cross section view from the bottom  
of the bag.  
\_\_\_\_\_  
\_\_\_\_\_  
\_\_\_\_\_  
\_\_\_\_\_  
\_\_\_\_\_  
\_\_\_\_\_  
\_\_\_\_\_

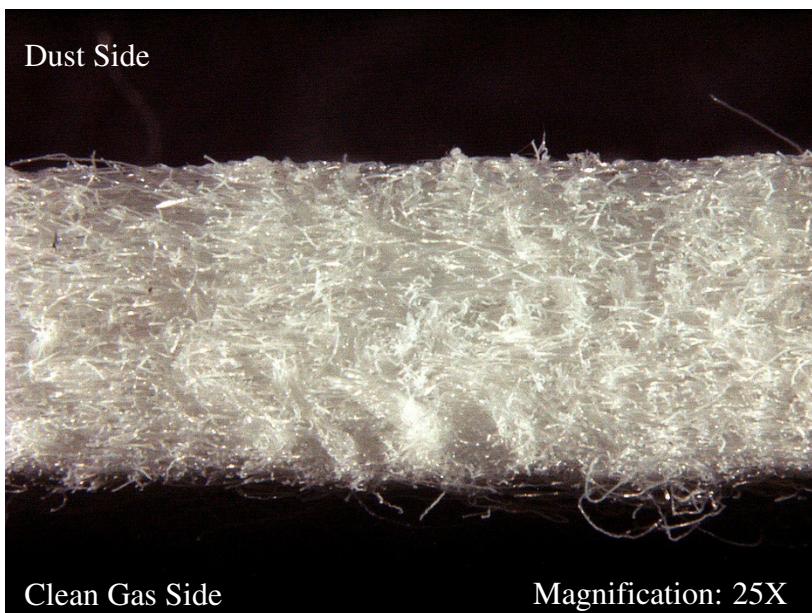
**Text:** Photograph # 6  
Cross section view from a clean,  
unused sample of 18 oz/yd<sup>2</sup>  
unsupported, singed polyester felt for  
comparison against the used felt  
shown in Photographs #3, #4 and #5.  
\_\_\_\_\_  
\_\_\_\_\_  
\_\_\_\_\_  
\_\_\_\_\_  
\_\_\_\_\_

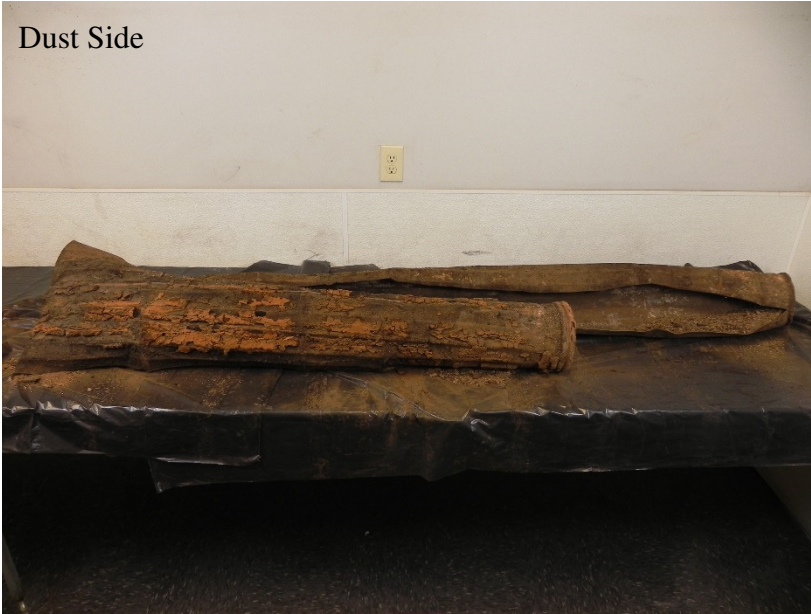
**Text:** Photograph # 7  
Dust Side view of the filter bag as  
received to the lab. The filter bag  
was slit lengthwise during removal.  
A heavy layer of aggressively  
attached dust was evident the entire  
length of the filter bag.

**Dust Cake Formation:** A thick, bark-like layer of reddish-brown dust coated the entire outside of the bag, with a thinner layer of dust coating the interior side.

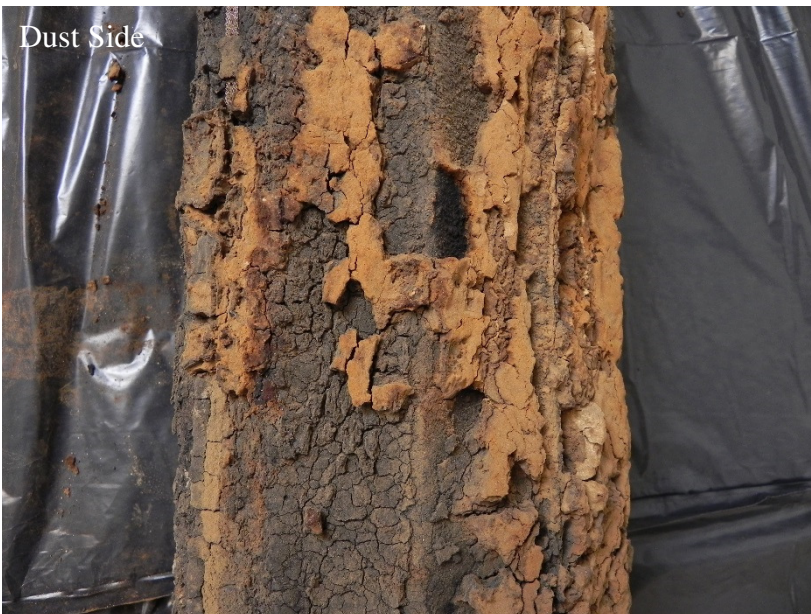
**Text:** Photograph # 8  
Dust Side view of the top portion of  
the bag illustrating thick, bark-like  
agglomerations adhered to the  
external bag surface.

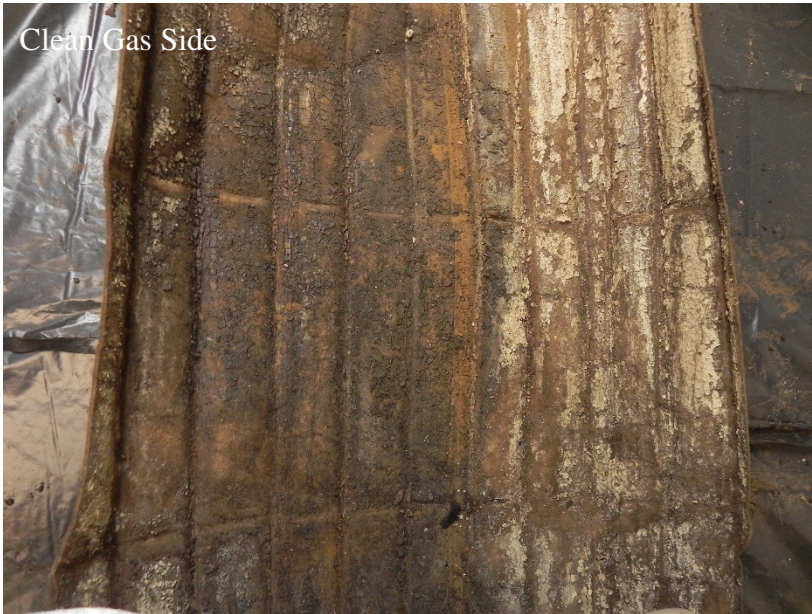
**Text:** Photograph # 9  
Clean Gas Side view showing a heavy layer of ubiquitous brown, red, and white dust coating the interior bag surface. This photograph is representative of the entire length of the filter bag on the interior side.
